Sloshing in membrane LNG carriers and its consequences from a designer's perspective

T. Gavory, P.E. de Seze
Marketing dep't, Gaztransport & Technigaz
Liquid motion dep't, Gaztransport & Technigaz
Saint-Rémy-lès-Chevreuse, France

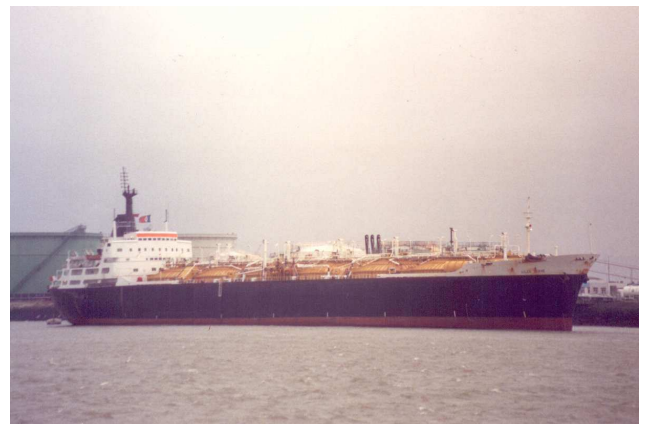
In parallel, French shipyards and gas companies worked together to develop and build a prototype, called Beauvais, with three tanks each of a different kind, for a total capacity of 640m^3 , with the aim to gain experience and knowledge in the mastering of LNG tank design and construction. These two first-of-a-kind vessels led to the delivery of the first "commercial" LNG carriers, Methane Princess and Methane Progress in the US, $28,300\text{m}^3$ each, using nine Aluminium alloy tanks with Balsa wood / fibreglass insulation in 1964, and the Jules Verne in France, $25,840\text{m}^3$ of LNG stored in seven 9% Nickel-Steel alloy tanks with Perlite and "Klegecell" (expanded vinyl chloride with a density of 55kg/m^3) in 1965.

Figure 2: Jules Verne LNG Carrier

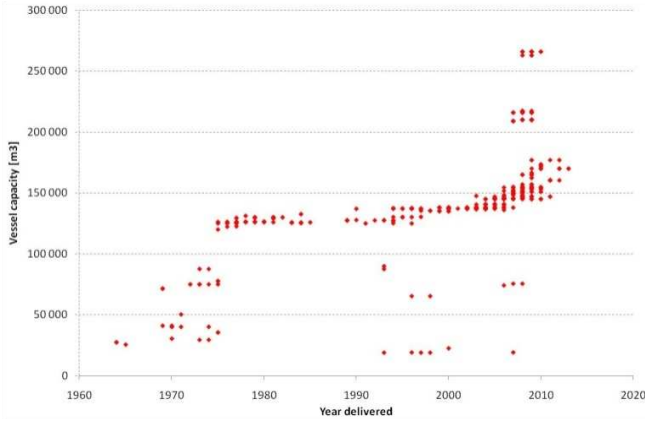
Figure 3: LNGC Fleet capacity evolution from 1960 to 2015

techniques during the last four decades have permitted increases in the ship's cargo capacity while reducing the number of tanks. At the beginning of the new millennium, the standard capacity of an LNG carrier, whether it was of spherical or membrane type, was in the range of 138,000m³ divided into 4 tanks (Jean, 1998), and the first of the 14 ordered giant LNG carriers (>260,000m³ in 5 tanks) was delivered in 2008.

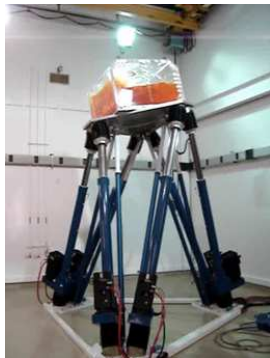
- Simulate more accurately the ship motions at sea, with six degrees of freedom.

Figure 8: 6 d.o.f. test rig

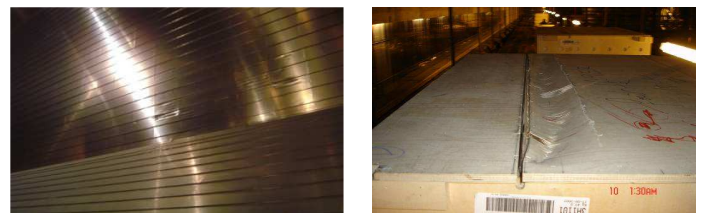
This is why the information coming from Navantia shipyard in El Ferrol, Spain during spring 2006 came as such a shock for all the people who received it. The Catalunya Spirit, a 138,000m³ LNG carrier delivered in 2004 had entered for a schedule routine dry-dock inspection, and due to a malfunctioning cargo pump a decision was taken to open the cargo tanks and inspect the other cargo pumps. Upon entering the tanks it was noticed that the cargo containment system appeared to be damaged in a number of locations and a more detailed inspection was initiated. Investigation revealed that the membrane was indented in tanks 2, 3 and 4, in a zone just above the upper knuckle of the lower chamfer on both sides of the tanks, indicating that the box covers behind the membrane were indented. In some areas, the invar tongue immediately above the indents had been bent upwards and the majority of the most indented areas were located right below the invar tongue. This seems to indicate the existence of a local over-pressure due to the presence of the invar tongue. This was the first real evidence of the strong influence of local effects on the sloshing impact pressures, and some extensive studies were consequently launched on this particular subject.

Figure 10: indented primary membrane (left) and deflected top cover (right)

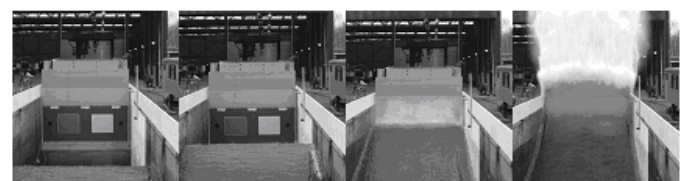
Full scale tests have been launched through SLOSHEL JIP (Brosset, Mravak, Kaminski, Collins, Finnigan, 2009) or with strain gauges directly installed in the insulation components of sailing LNG carriers.

Figure 12: Full scale impacting wave during SLOSHEL JIP
